Case study

Vision system inspects automotive sub-assembly

A Tier 1 supplier to the automotive industry has installed a vision system to inspect the front and rear suspension corner module assemblies of automobiles prior to shipment to a large UK based automobile manufacturer.

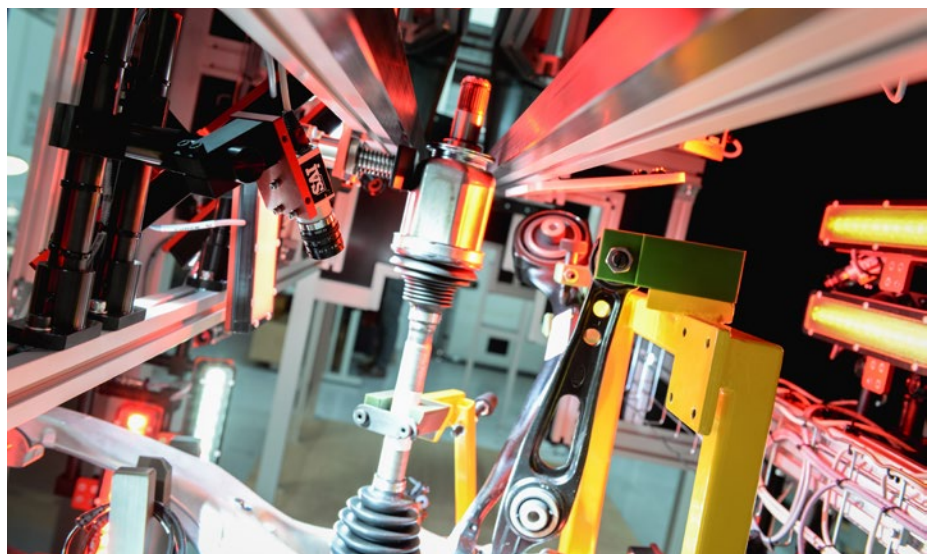
Figure 1: A multi-camera vision inspection system performs a final inspection on several key component parts of fully assembled front and rear suspension corner modules produced at a UK Tier 1 automotive supplier.

have now developed a vision system specifically for the task (*Figure 1 below*).

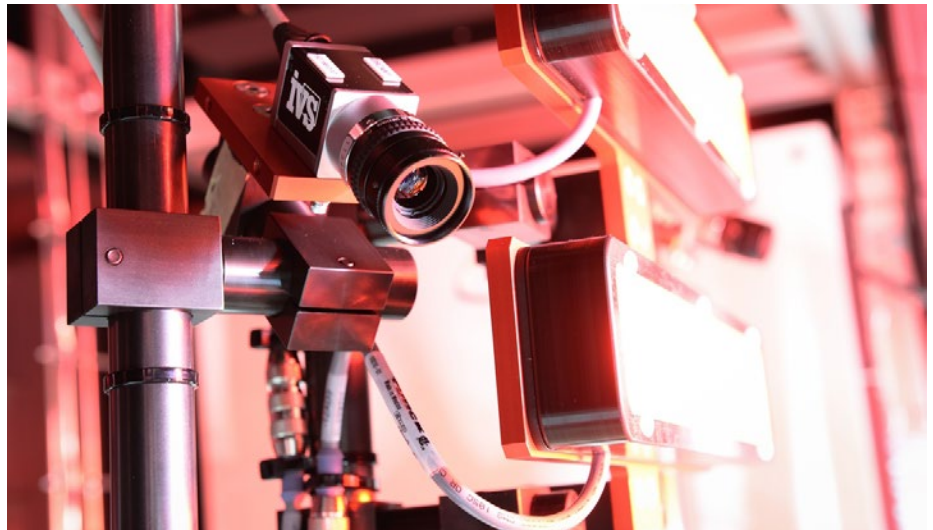
Figure 1a: An IVS CCD camera captures a monochrome image of the shaft of the drive shaft which is backlit by a red LED.

One important inspection task performed by the system is to check whether the correct size of drive shaft has been installed in each corner unit. To do so, an IVS monochrome 1296 x 966 pixel CCD camera captures a monochrome image of the shaft of the drive shaft which is backlit by a red LED (*Figure 1a*). The image is then processed to determine the location of the edges of each side of the drive shaft from which its width can then be determined. The unique width can then be correlated with the model type of drive shaft fitted to the assembly (*Figure 2*).

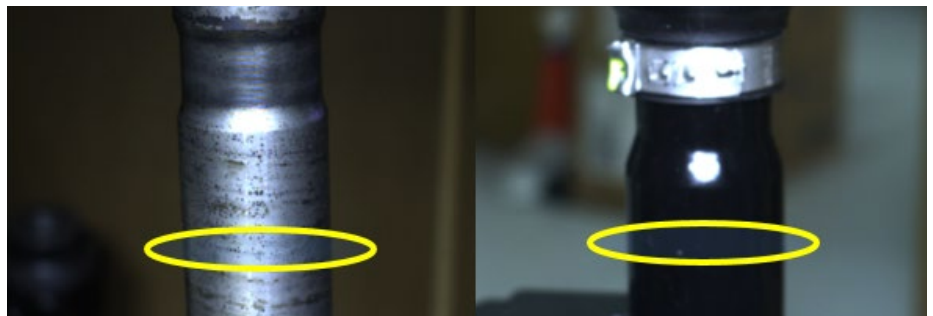
Figure 2: To check whether the correct size of drive shaft has been installed in each corner unit, an IVS monochrome camera captures an image of the shaft of the drive shaft which is backlit by a red LED unit. The image is then processed to determine the location of the edges of each side of the drive shaft from which its width, and the model of the drive shaft, then be determined.

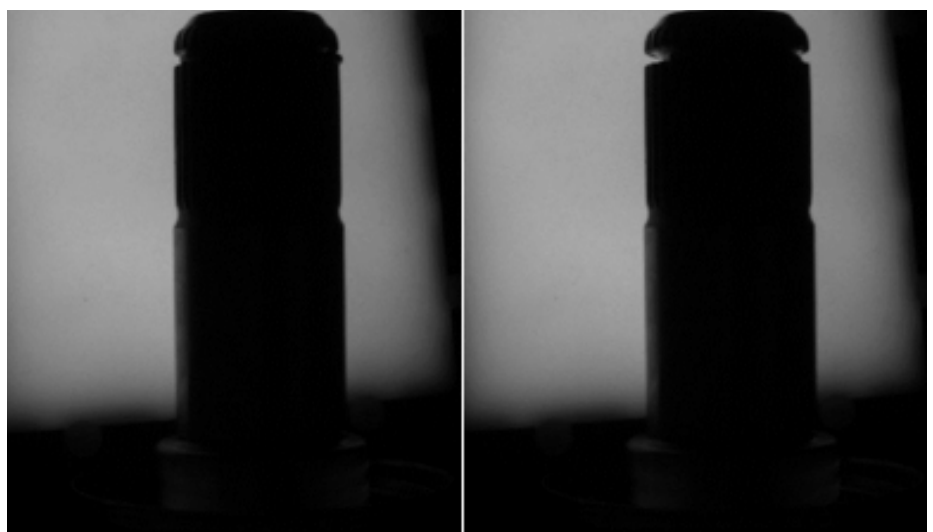
Figure 3: Two monochrome CCD cameras are used to capture images from two different perspectives of the regions surrounding the recession in the drive shaft into which the retaining ring has been fixed. By analyzing the contrast of the regions surrounding the recessions, it is then possible to determine whether the retaining ring is present.

Hence, two IVS monochrome 1296 x 966 pixel CCD cameras were deployed to capture two images from two different perspectives of the regions surrounding the recession in the shaft into which the retaining ring has been fixed. By analyzing the contrast of the region surrounding the recessions in the backlit images, it is then possible to determine whether the retaining ring is present (*Figure 3*).

Because the left hand and right hand of the suspension corner module assemblies are fitted with drive shafts of two different lengths, the dual camera monochrome system backlit by a red LED was replicated at two different heights in the vision inspection station, in order that the system could determine whether the retaining ring was present on different sizes of drive shafts.

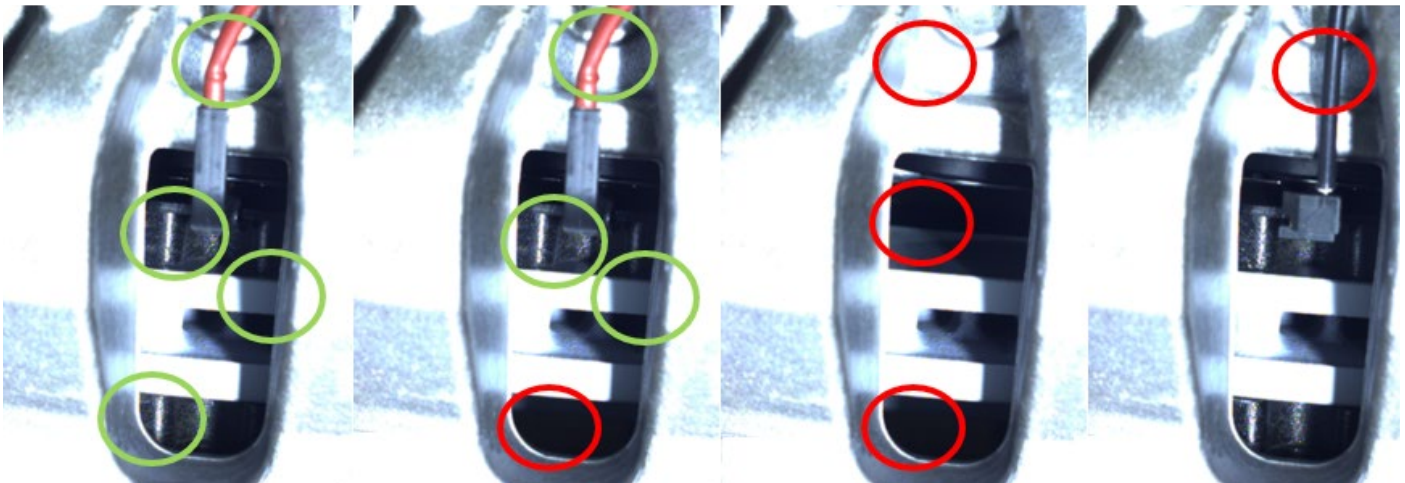
Figure 4: Two cameras are used – one on each side of the assembly – to accommodate left and right handed suspension corner modules. The camera captures an image through the side of the brake caliper and can view both brake pads, the disk and the brake pad warning indicator when fitted.

The cameras are positioned such that they can not only capture an image of the brake pads, but also the brake disk and the brake pad warning indicator. To ascertain the presence of the brake pads, the brake unit is illuminated and the presence of the reflected light in the image can then be verified to provide a measure of whether a brake pad has been fitted or not.

IVS software to determine the width of the disk used in the unit. The system software also finds a region of interest around the image of the brake pad warning indicator captured by the same color cameras and from an analysis of the color of the indicator lead, the model of indicator can be verified (*Figure 4*).

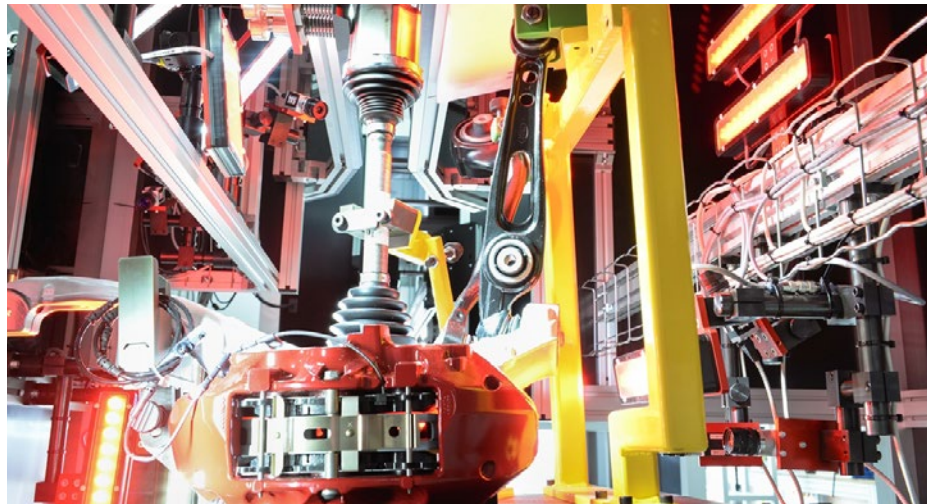
Figure 4a: Two IVS 1296 x 966 CCD color cameras capture images of the top of the calipers fitted to both the left hand and one for the right hand assembly. By verifying the position of a key feature on the top of the caliper pad, the system software determines whether a right or a left handed caliper has been fitted to the unit.

To do so, two IVS 1296 x 966 CCD color cameras capture images of the top of the calipers fitted to both the left hand and one for the right hand assembly (Figure 4a). By verifying the position of a key feature on the top of the caliper pad, the system software determines whether a right or a left handed caliper has been fitted to the unit. The size of the caliper fitted to the unit is verified by calculating the distance between two bolts used to secure the two halves of the caliper assembly. The cameras also detect the presence or absence of a scoop used to force cool air into the brake assembly and from its shape, verify its type. In addition, the images is also processed to detect the presence, and to verify the type, of the fastener used to fix the scoop to the caliper (Figure 5).

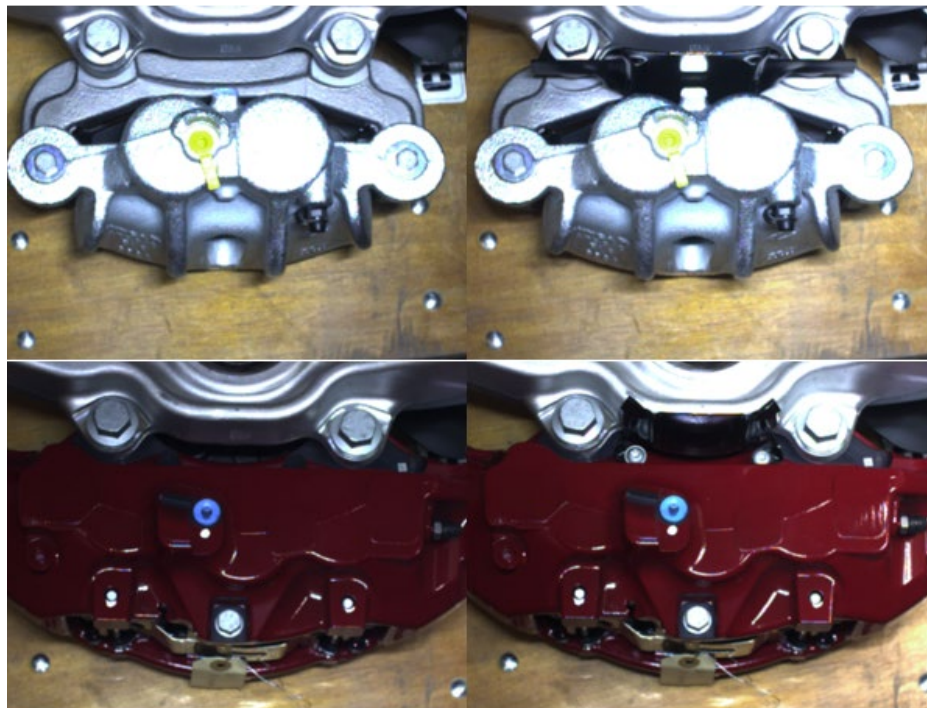
Figure 5: Two CCD color cameras are mounted above the brake caliper to enable an image of the top of the calipers fitted to both left hand and right hand units to be captured. By verifying the position of a key feature on the top of the caliper pad, the system software determines whether a right or a left handed caliper has been fitted to the unit. The size of the caliper fitted to the unit is verified by calculating the distance between two bolts used to secure the two halves of the caliper assembly. These two cameras also detect the presence or absence of a scoop used to force cool air into the brake assembly as well as its type. In addition, they can detect the presence of the specific type of fastener used to fix the scoop to the caliper.

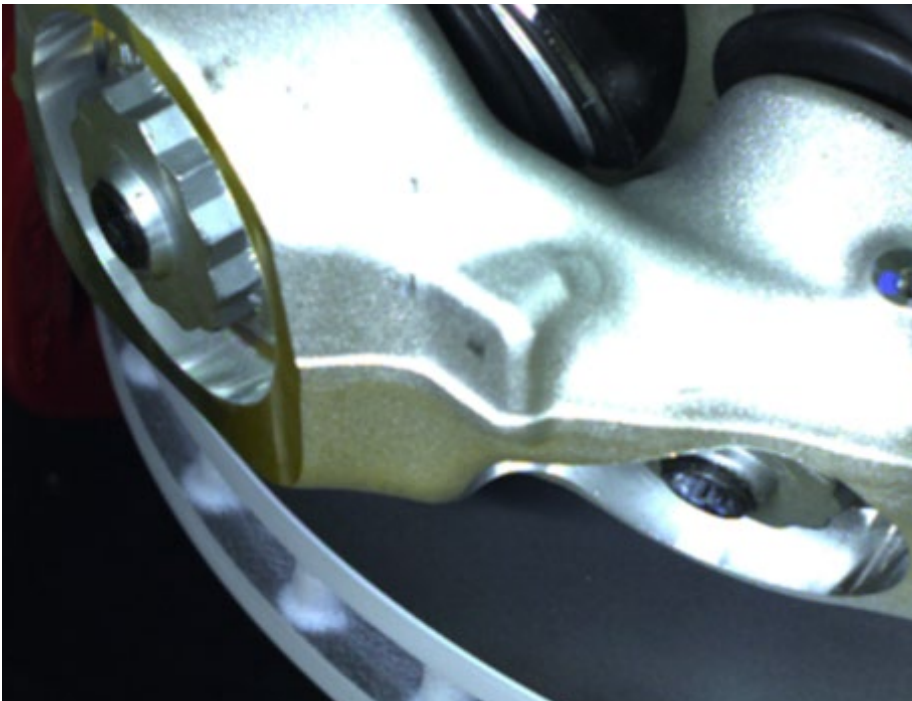
Figure 6: Two IVS 1296 x 966 monochrome CCD cameras lit by red LED line lights are mounted in the imaging station to enable images of both the left hand and the right hand side of the suspension arms of the corner module assemblies to be captured. Having captured an image of the end of the lateral and tension arms, the image is then processed to determine whether the arm nuts at the end of the suspension units are present and have been tightened.

The penultimate inspection made on the corner unit determines whether the arm nuts at the end of the suspension units are present and have been tightened. To do so, two IVS 1296 x 966 monochrome CCD cameras lit by red LED line lights are mounted in the imaging station, enabling images of both the left hand and the right hand side of the suspension arms of the corner module assemblies to be captured. The system software then determines whether the outline of the contour of the nuts are present in the image, and measures the distance

that the nuts protrude from the arm to determine whether they have been appropriately tightened (*Figure 6*).
