Case study

Vision system inspects heads-up displays for jet fighters

To perform a final inspection on assembled head-up displays (HUDs), an automated vision system is used detect the presence of screws, bolts and covers.

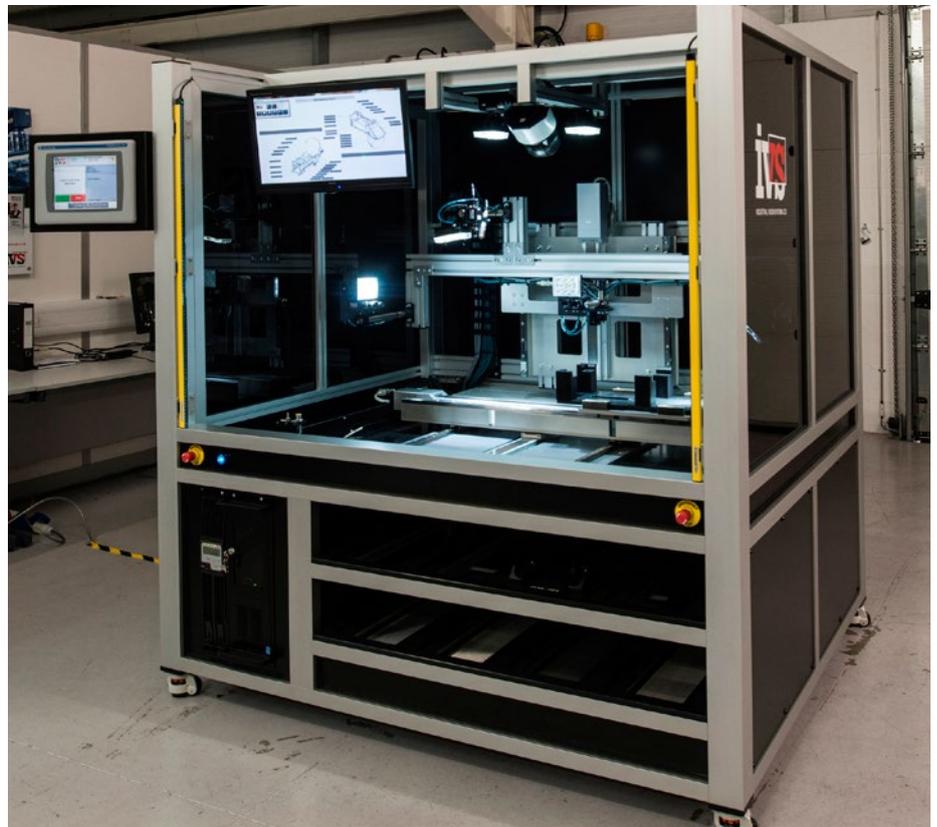
Figure 1: Industrial Vision Systems has developed a vision-based system that inspects head-up displays (HUDs) for presence of screws, bolts or covers and verifies that helicoils are properly placed in the machined aluminium castings.

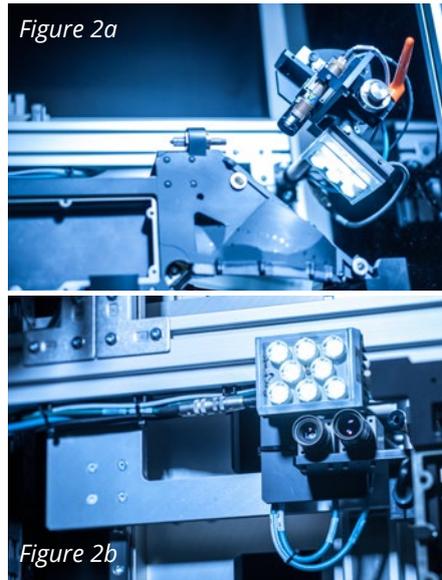
Figure 2a and 2b: Fig 2a shows the camera and laser in-line with a machined hole with the laser projecting a line into the hole to allow analysis of the helicoil.

Fig 2b shows the camera, laser and light mounted onto the Z axis gantry.

To perform inspection of the HUD, the system incorporates a gantry of cameras mounted on a linear drive that move in the z axis (Figure 2). The laser projection unit is mounted in-line with the camera to allow a single laser line to be projected into the machined holes on the HUD. In addition white LED lighting arrays were mounted above the camera to provide overall diffused lighting for surface inspection checks. The nest was mounted on two linear drives allowing it to travel in both the x and y axes. Using this setup, any point on the three inspection faces could be presented to a camera and light module for inspection.

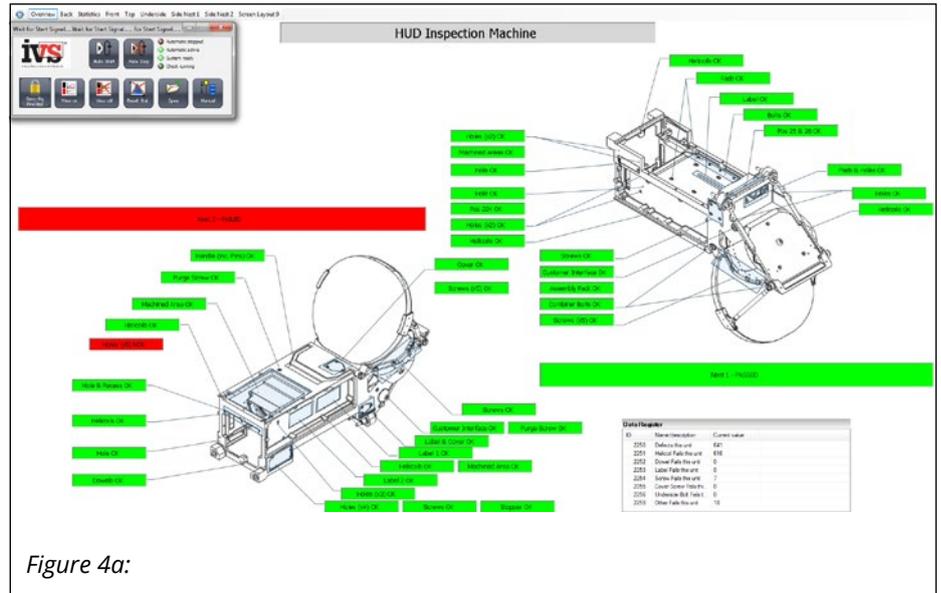
Figure 4a:

Figure 4a and 4b: The vision system's human machine interface displays detailed results history of the machine vision inspection process. Individual results for each inspection task are presented on a monitor in graphical form for the operator to visualise which tests have passed and which have failed. The HMI displays individual tags on the screen which color red or green during the inspection process to provide a clear indication of what parts have passed and failed during the process.

Such a complex array of inspection positions and requirements presented a further challenge in terms of displaying the final results to the operator in a usable format. Individual results for each position were collated into a report format that is automatically printed once the inspection has completed. The system also presents the data on a monitor in graphical form for the operator to visualise which tests have passed and which have failed. An overview screen shows the operator the results of groups of related types of checks for all faces of the HUD (Figure 4). If further detail is required, the operator can access additional screens of each individual face with every inspection result relating to that face displayed in a color coded layout.
